Baldwin Hills Dam Disaster

Jackson Orr

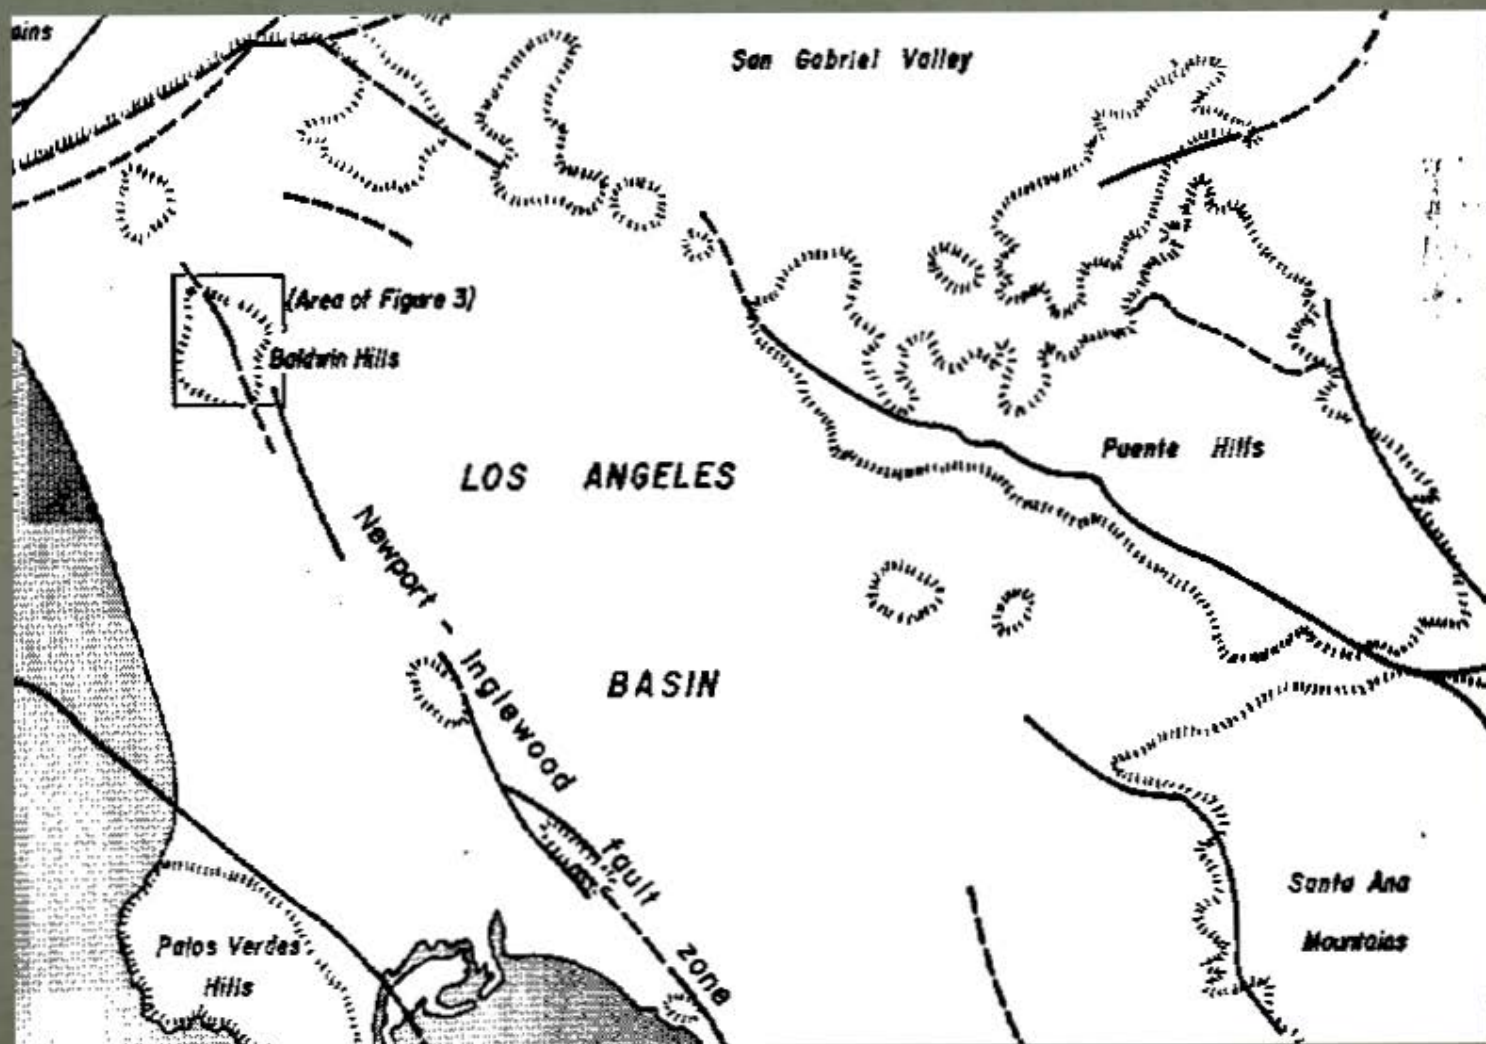
Geologic Site Map

- Initial surveys found that the selected site was near the Inglewood-Newport Fault Line
- Also, a few hundred yards away were the Inglewood Oil Fields
- Soil strata were found to be very unstable underneath the site due to constant changes because of tectonic movement and waste excretion from the oil fields

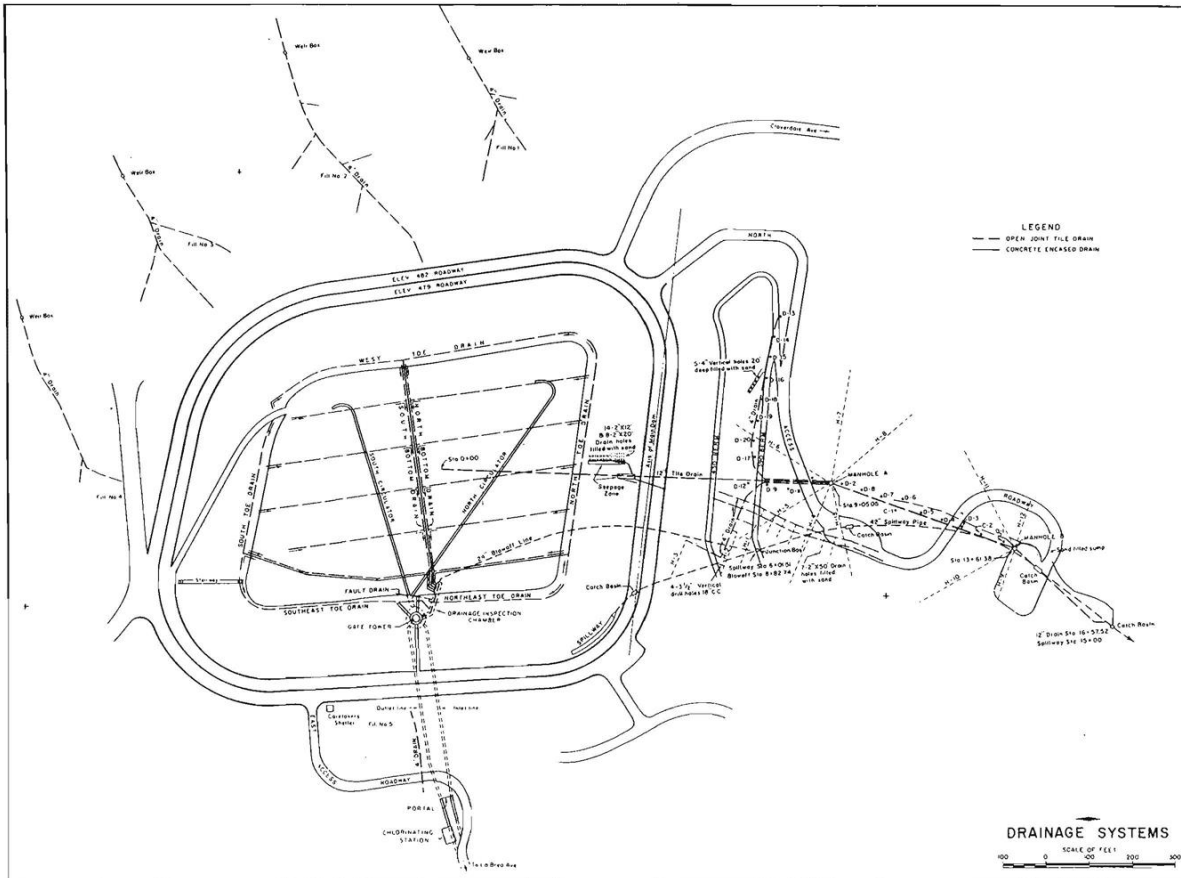
Fig. 2-2. Drainage systems, Baldwin Hills Reservoir.

- The bottom of the reservoir consisted of many layers of soils that were meant to prevent leakage of water from reservoir
- The layers from top to bottom were:
 - Compacted Earth graded with a steep slope
 - Drainage Piping surrounded by lightly cemented gravel
 - 1/4" layer of pea-sized gravel that was lightly cemented
 - 1/4" layer of asphalt with cotton reinforcement weaving were needed

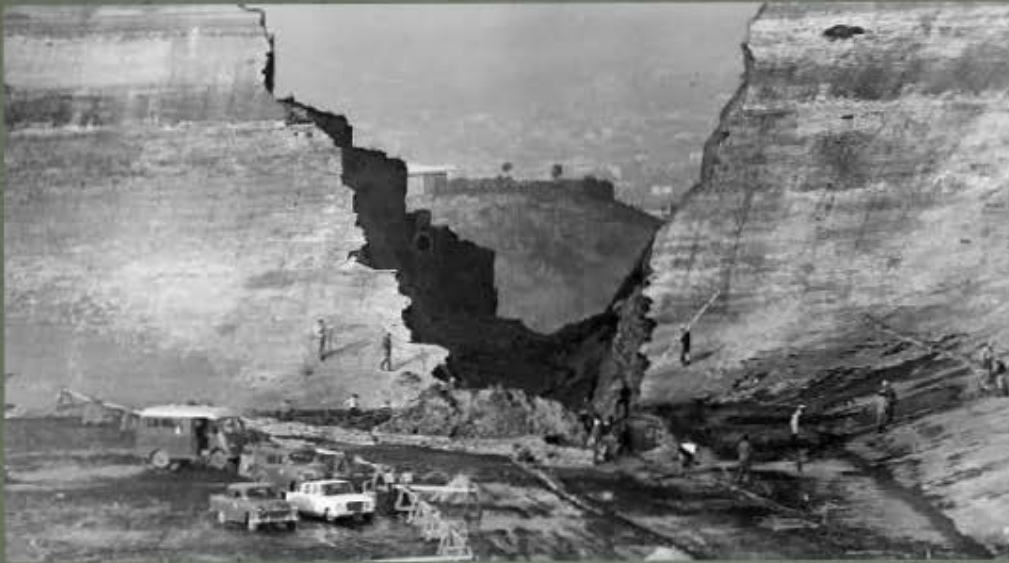
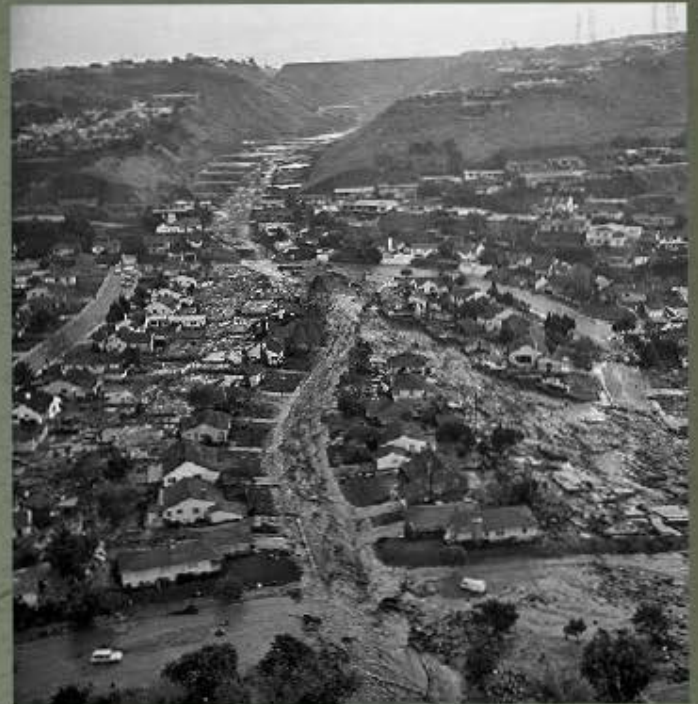
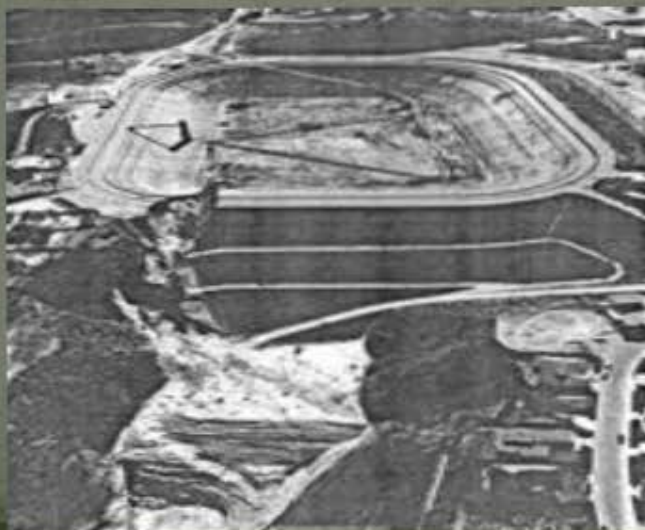
Critical Failure (cont.)

- On the morning of December 14, 1963 at 11:15 AM a noticeable amount of water was gushing into the spillway from the reservoir.
- 3 hours later, the dam burst forth a raging torrent of water that devastated the lower surrounding residential areas.
- If it were not for the early warning provided by the engineers to the police that day, a lot more than 5 people would have lost their lives.

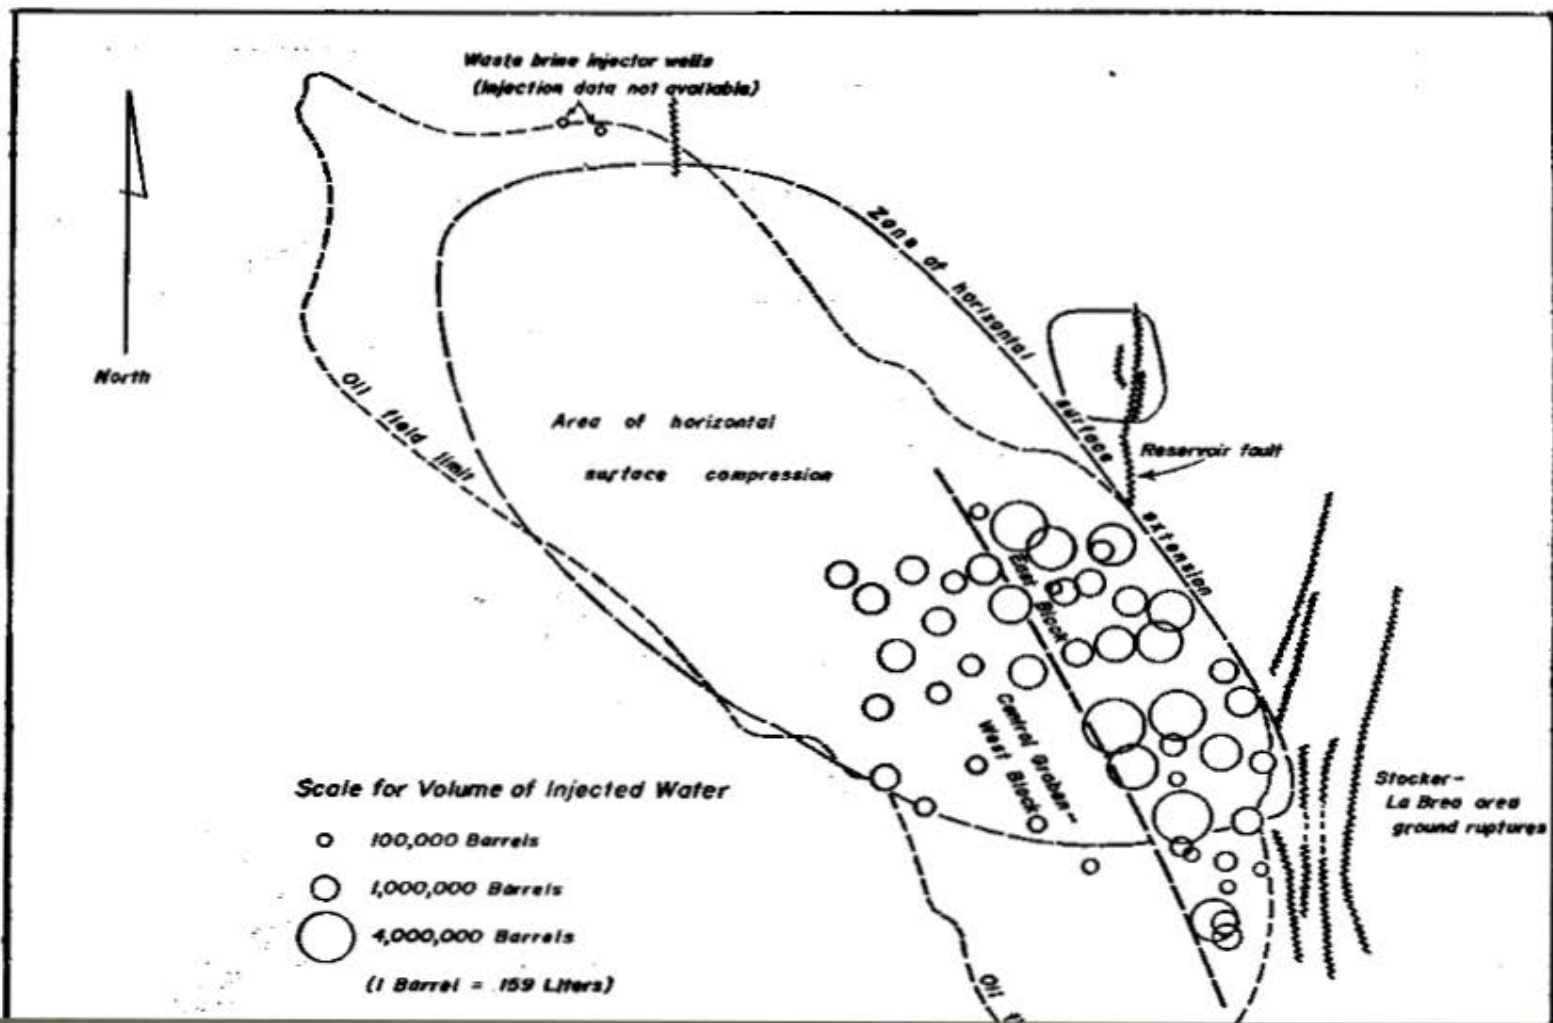
Post Failure Analysis (cont. 3)

- Four days after the disaster took place, a 7" overthrust was found spanning the length of the reservoir along with many holes in the asphalt layer.
- Sinkholes were also very prevalent in the compacted earth cover lining, some being several feet in diameter.
- It was later tested that if an extra lining of a silty-clay like layer was placed under the asphalt layer, it would have allowed for a more "plastic" support to the bottom of the reservoir, and might have prevented the critical failure.

- Many prevalent engineers gathered for conference after conference to find out who or what was to blame for the disaster.
- One of the conferences involved Casegrande himself, who stated that the failure was due to previous settlement of soil due to early movements in Faults I & V causing an unstable formation that continuously deformed during the lifetime of the reservoir. Especially during the compaction phase of the lining.

- While many of the engineers believed fault line movement was the cause, others argued that the settling of underlying soil strata due to oil field depletion from the Inglewood Oil Fields was to blame
- These oil fields had been subjected to a process known as hydraulic fracturing for many years, and some engineers believed that the build up of excess gases from the fracturing caused the soil strata to settle leading to the failure and Baldwin Hills.
