Baldwin Hills Dam Disaster

Jackson Orr

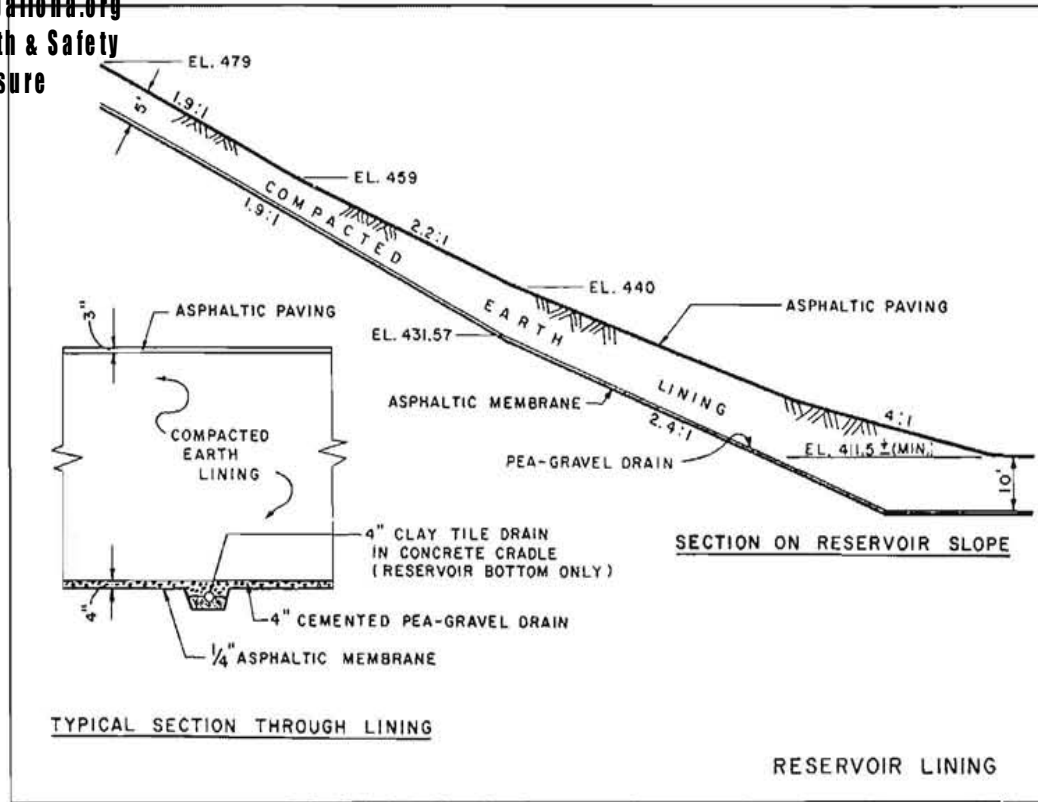
Soil Compaction and Layering (cont.)

- The bottom of the reservoir consisted of many layers of soils that were meant to prevent leakage of water from reservoir
- The layers from top to bottom were:
 - Compacted Earth graded with a steep slope
 - Drainage Piping surrounded by lightly cemented gravel
 - 1/4" layer of pea-sized gravel that was lightly cemented
 - 1/4" layer of asphalt with cotton reinforcement weaving were needed
